Summary: In response to seaweed impacts recently observed throughout the Turks and Caicos in 2017 and 2018 coupled with the likelihood these events will continue to occur, a seaweed mitigation gate and water pump was designed to protect a swimming lagoon during periods of elevated seaweed impacts.

Key Project Elements:

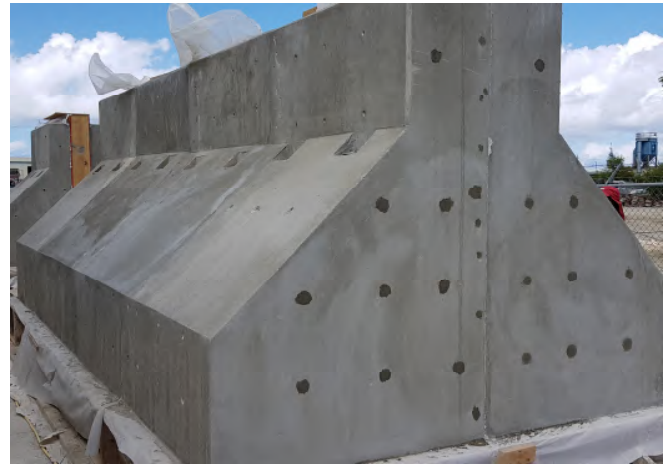
Concrete Modules for Mitigation Gate

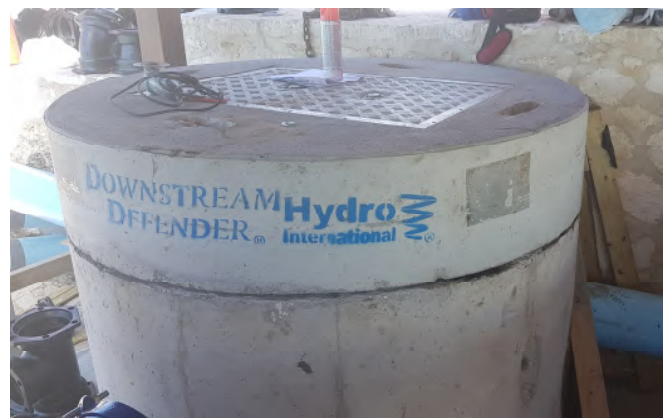
Sediment Separator Installation

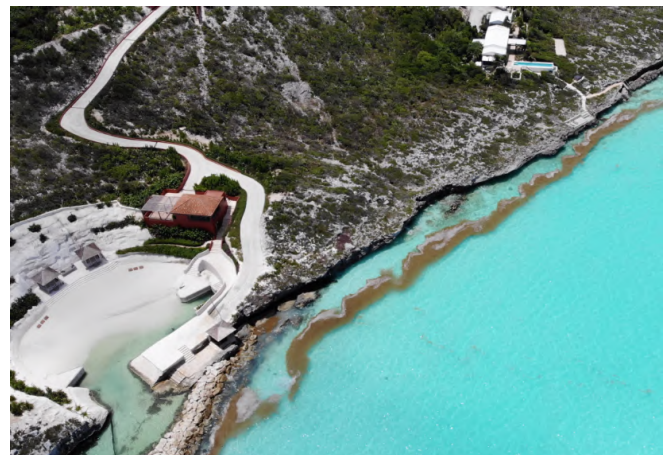
Sargassum Seaweed Bypassing the Lagoon

A seaweed attenuation study was implemented inclusive of time lapse photography, wave spectral analysis, water currents and metrologic data to determine the best solution. The sea gate was designed to be as large as is technically feasible, whilst being concealable within the existing break-water structure. Additionally, a water pump, sediment separator (filtration system), and two flushing pipes with outgoing check valves were incorporated into the design to further reduce the seaweed intrusion and promote flushing when the sea gate is closed.
